Interstate 5 – South Bound
KP 0.0 to KP 2.7

DOWEL BAR RETROFIT EVALUATION

DISTRICT 12
Orange County
Interstate 5

Contract Number: 12-093904

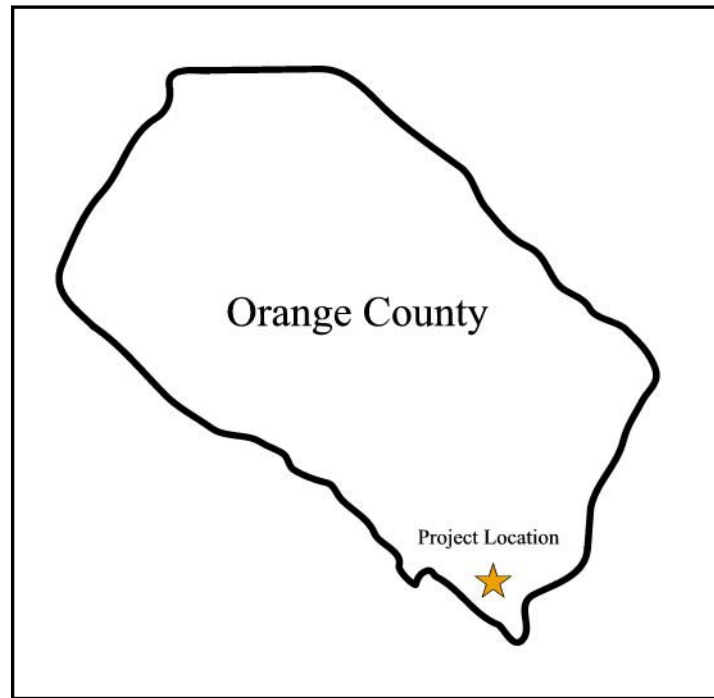
Figure 1. Project Location

A current dowel bar retrofit project in District 12 on Interstate 5 (I-5), near San Clemente in Orange County, is exhibiting signs that construction work is not conforming to the project plans and specifications. The project is between the El Camino Real Under crossing and the San Diego County Line. Recent counts show that this segment is subjected to an Annual Average Daily Traffic (AADT) from 115,000 to 145,000.

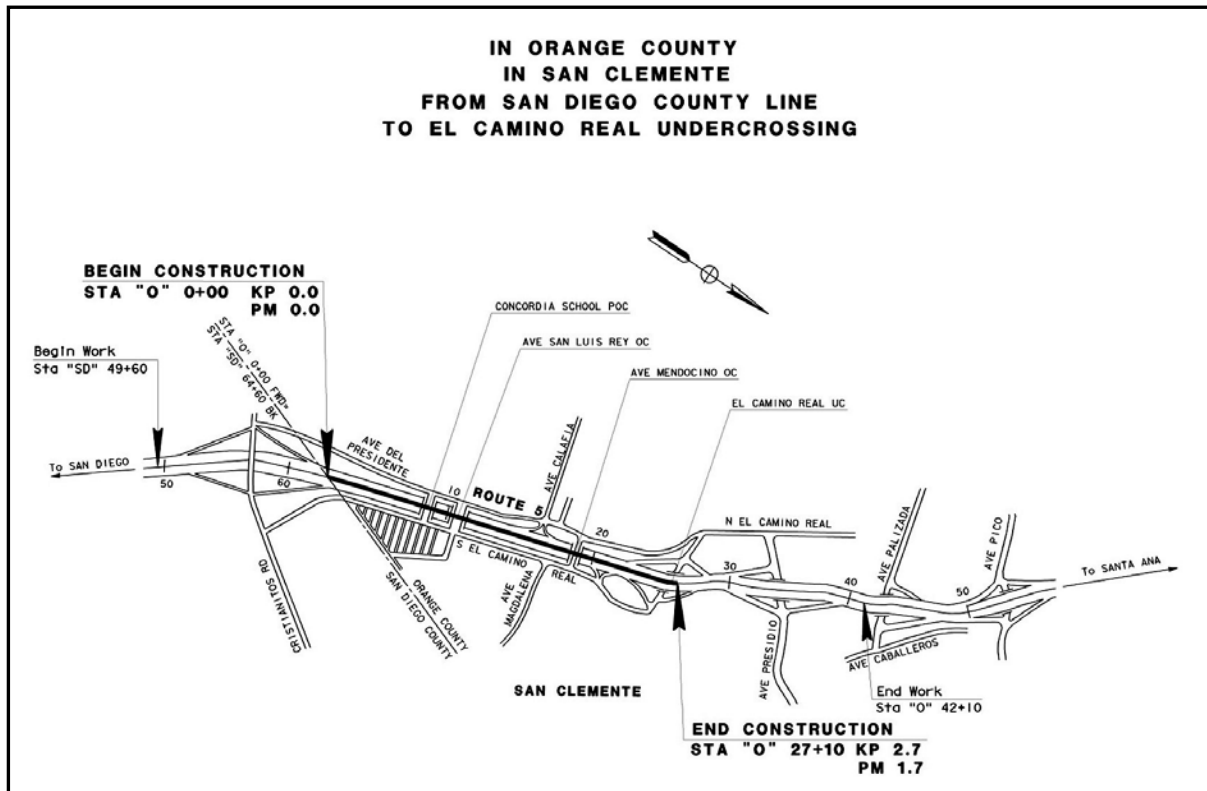
Figure 2. Project Limits

This project is rehabilitating a 2.7-km long segment of I-5 primarily by retrofitting and grinding most of the existing panels and by replacing failed panels in both the northbound and southbound directions. The project limits extend from the San Diego County Line (station 0+00) to the El Camino Real Under crossing (station 27+10).

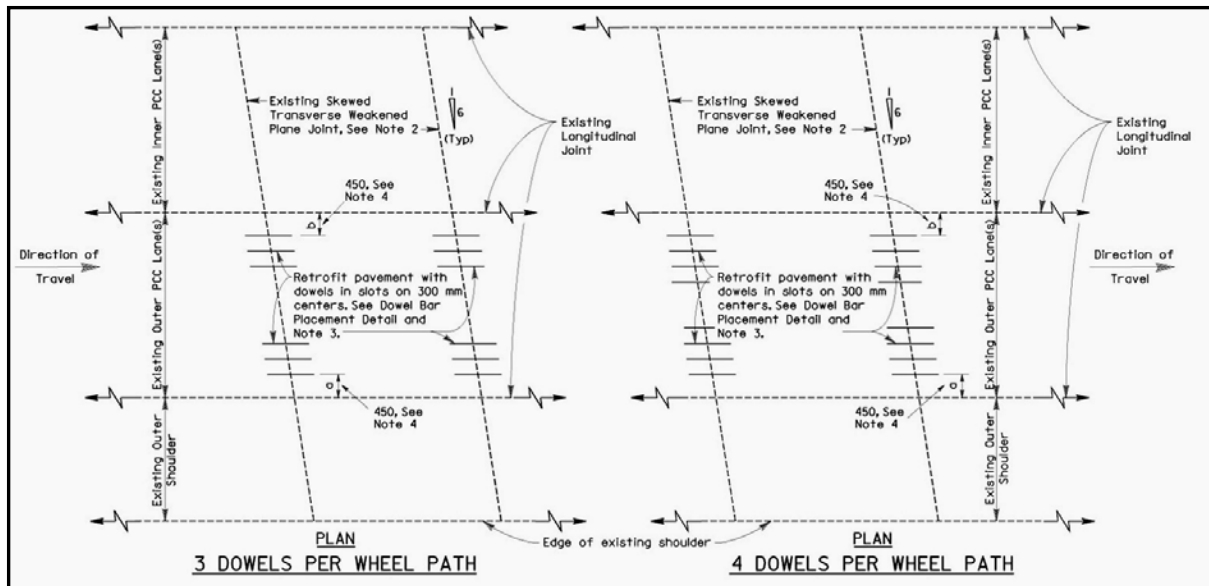
Figure 3a. Dowel Bar Retrofit Plan

The rehabilitation project is currently ongoing. The limits for the dowel bar retrofit, grinding and slab replacement are from station 0+00 to station 27+10 in both the northbound and southbound directions (Figures 3a and 3b). Specific locations for the work performed can be found on the project plans.

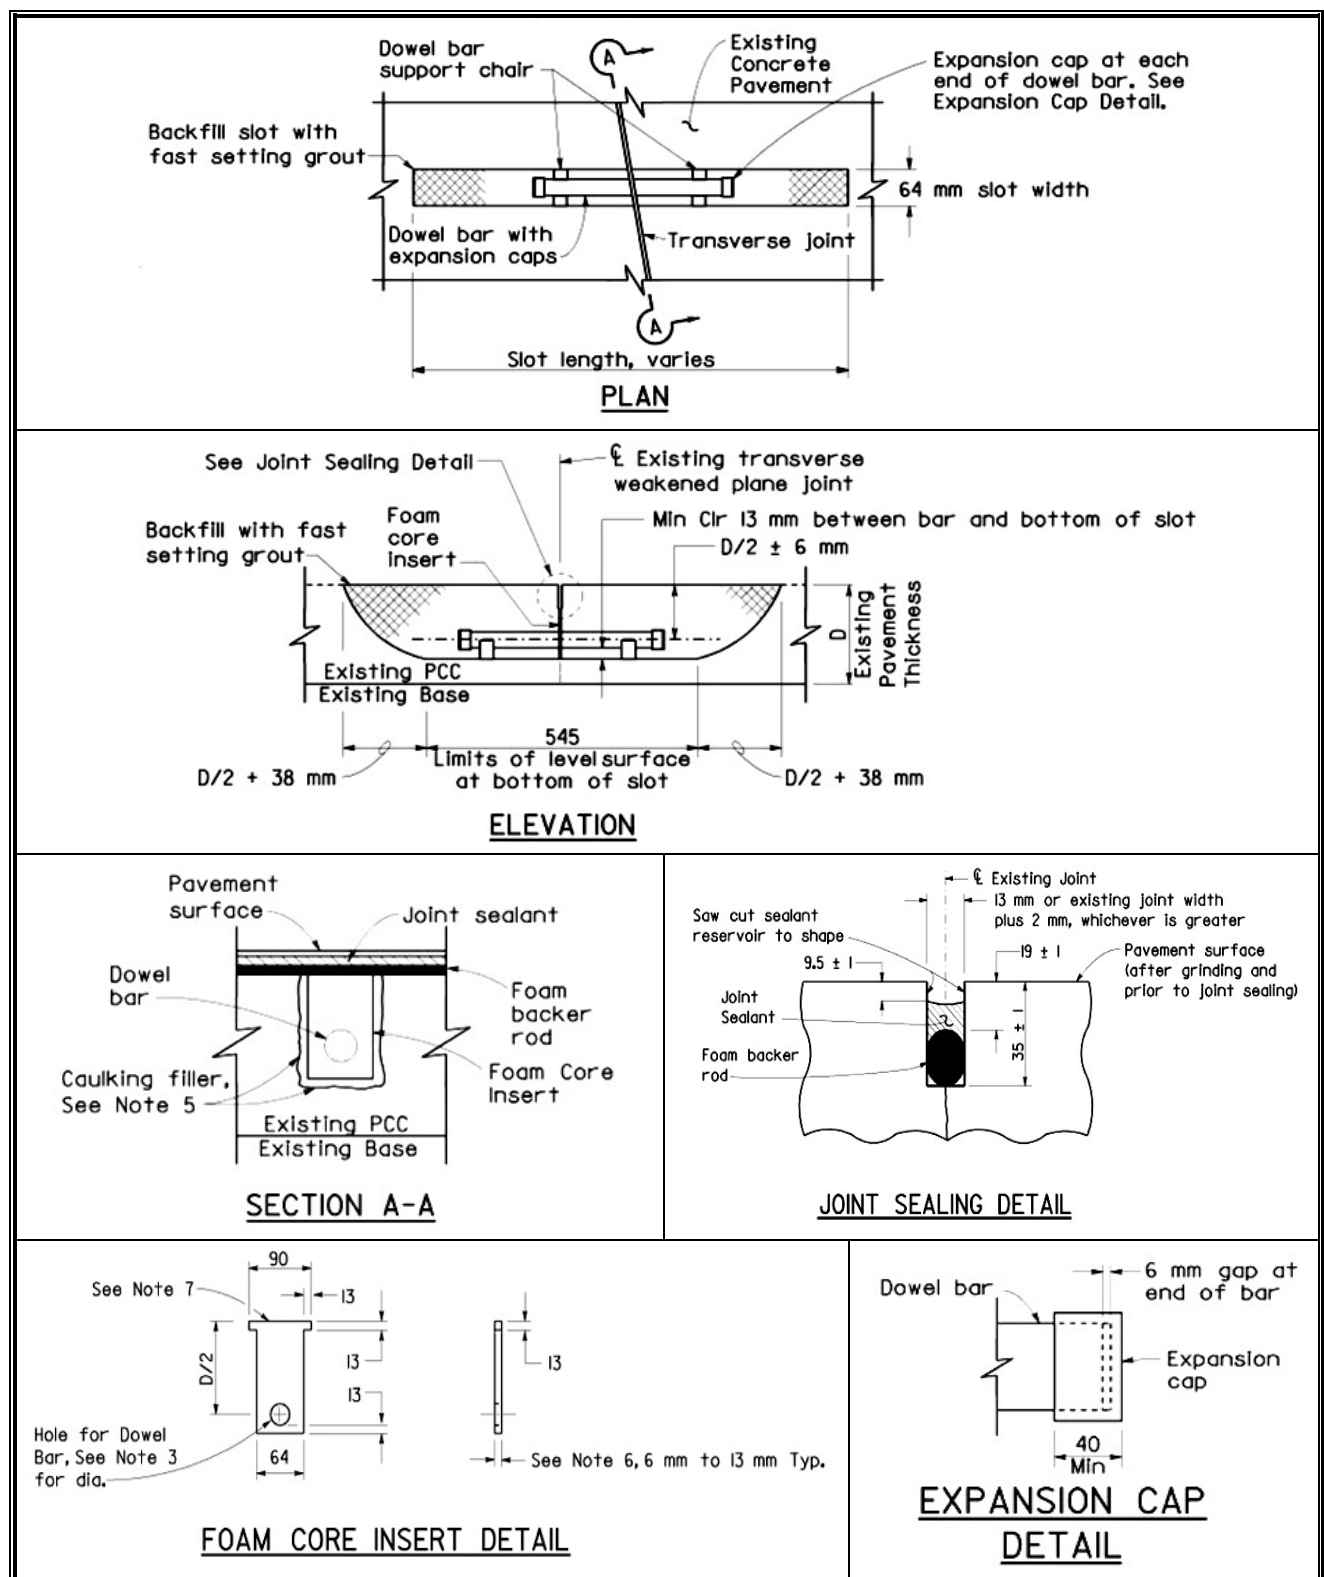
Figure 4. Dowel Bar Retrofit Details

The retrofit requires that dowel bars be installed in the transverse joints of the existing panels. Dowel bars are installed by saw-cutting slots parallel to the direction of traffic in the existing pavement. A dowel bar, with a foam board insert and chair supports, is placed in each slot. The slots are then backfilled with fast setting grout (Figure 4). The fast setting backfill grout is required to be finished 3 ± 1 mm above the existing pavement surface and ground smooth within 30 days after the slots are cut.

The dowel bars are specified to be 457-mm long, 38-mm diameter epoxy-coated smooth bars evenly spaced at 305-mm intervals, in the inner and outer wheel paths of the lane. The dowel

bars should be placed at a depth where the dowel centerline is at mid-depth of the pavement slabs. The project plans show the concrete pavement in lane 4 to have a depth of 275 mm.
